COMPLAINT

ALLEGATION OF PROBABLE VIOLATION(S) OF SOUTH DAKOTA ONE CALL LAWS

TYPE OF FACILITY INVOLVED: 2" polyethelyne natural gas main OPERATOR OF FACILITY (IF KNOWN): Montana-Dakota Utilities Co.

ADDRESS/LOCATION OF PROBABLE VIOLATION: 16630 Elk Horn Rd, Piedmont, SD

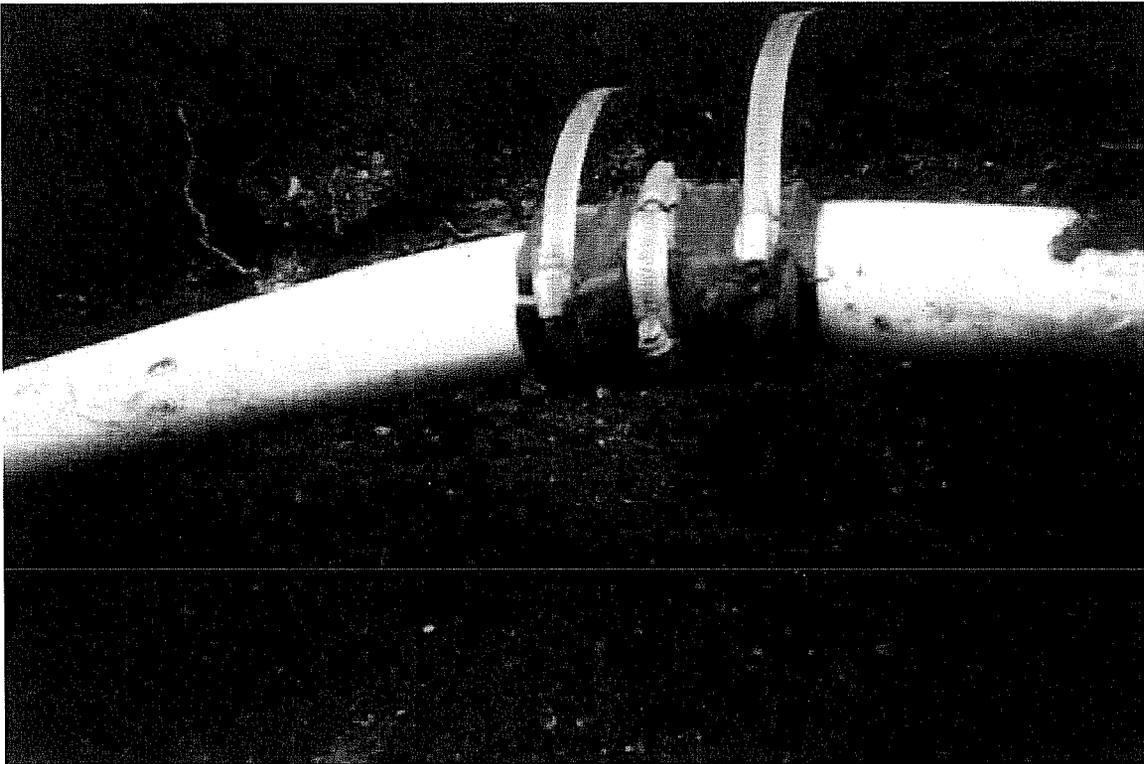
I (Henry McIntosh) took some pictures of what I saw from the water box and the furnco on the 2" gas main. After we fixed the damaged pipe we noticed that the gas line was scraped too more times besides the hole that was in the gas line.

Close-up of damage and repair,

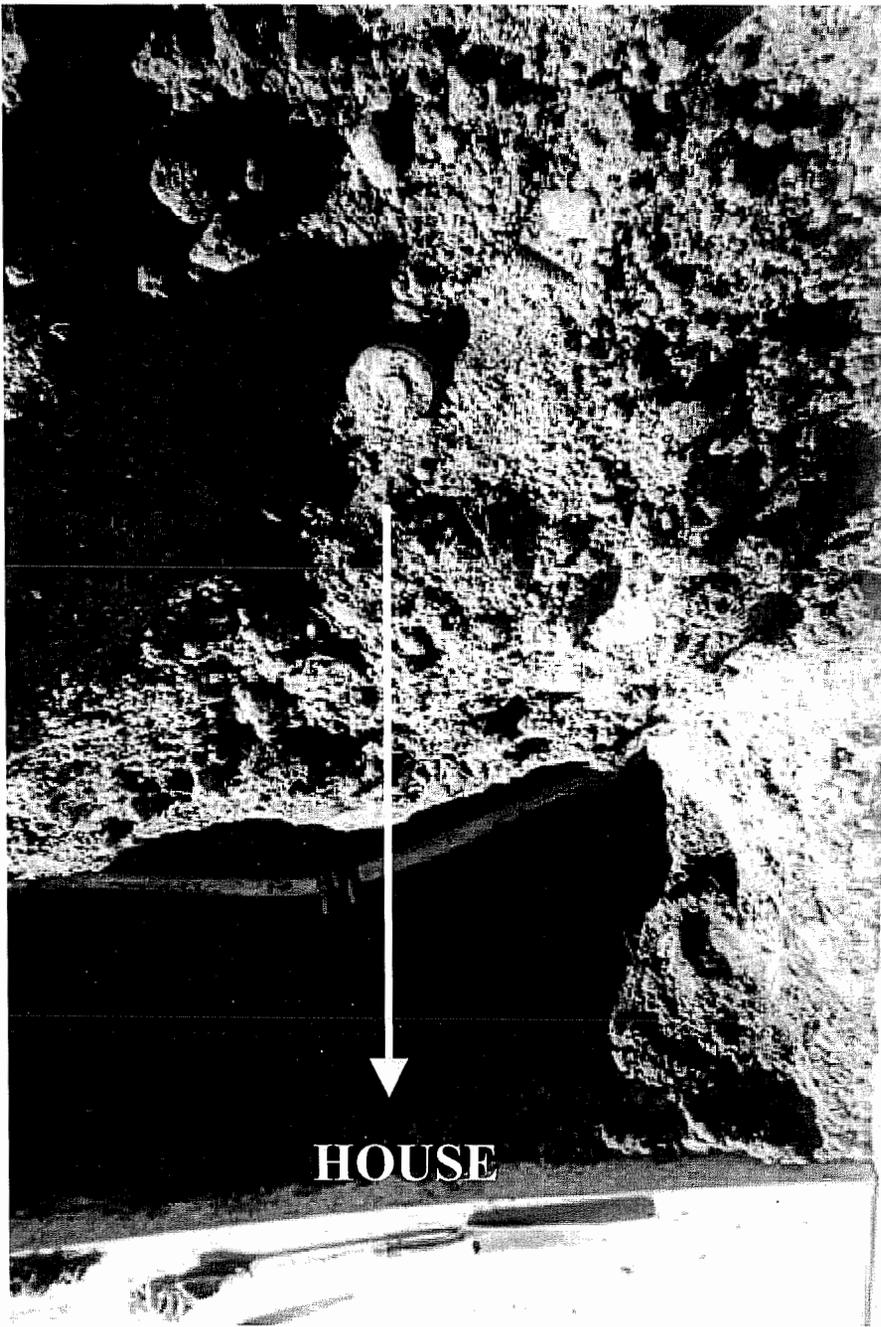
Water curb valve in relation to the damage line.

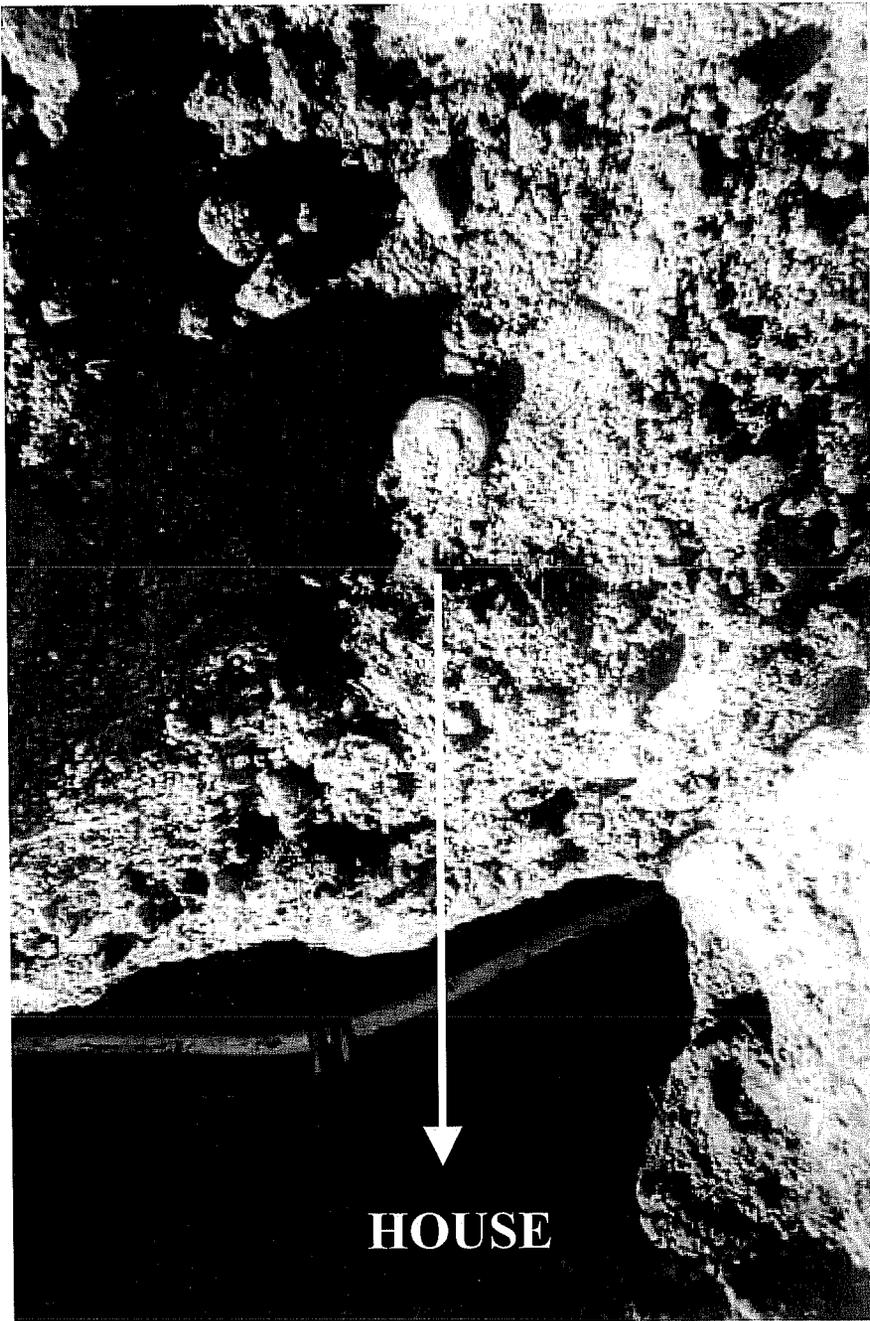
Another view of the water curb stop in relationship to the damage.

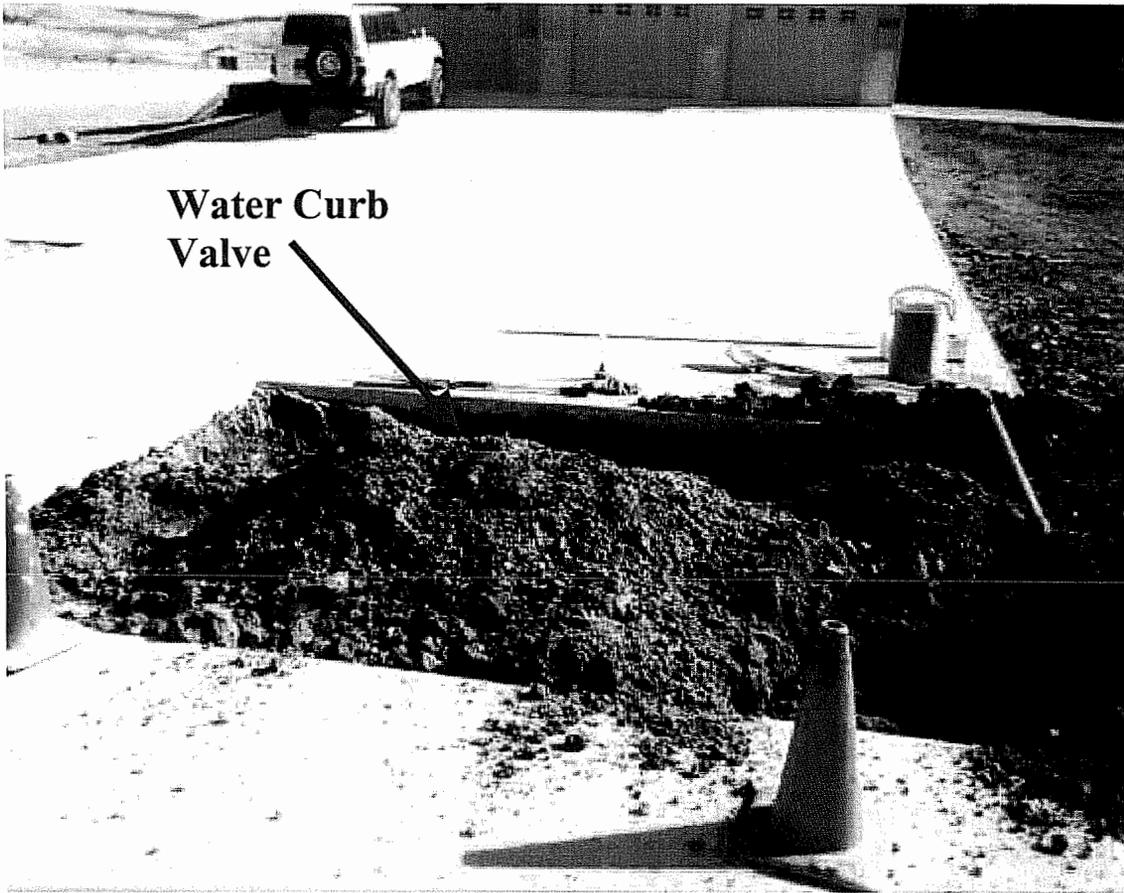
A view of the concrete removal and excavation in relation to the house.

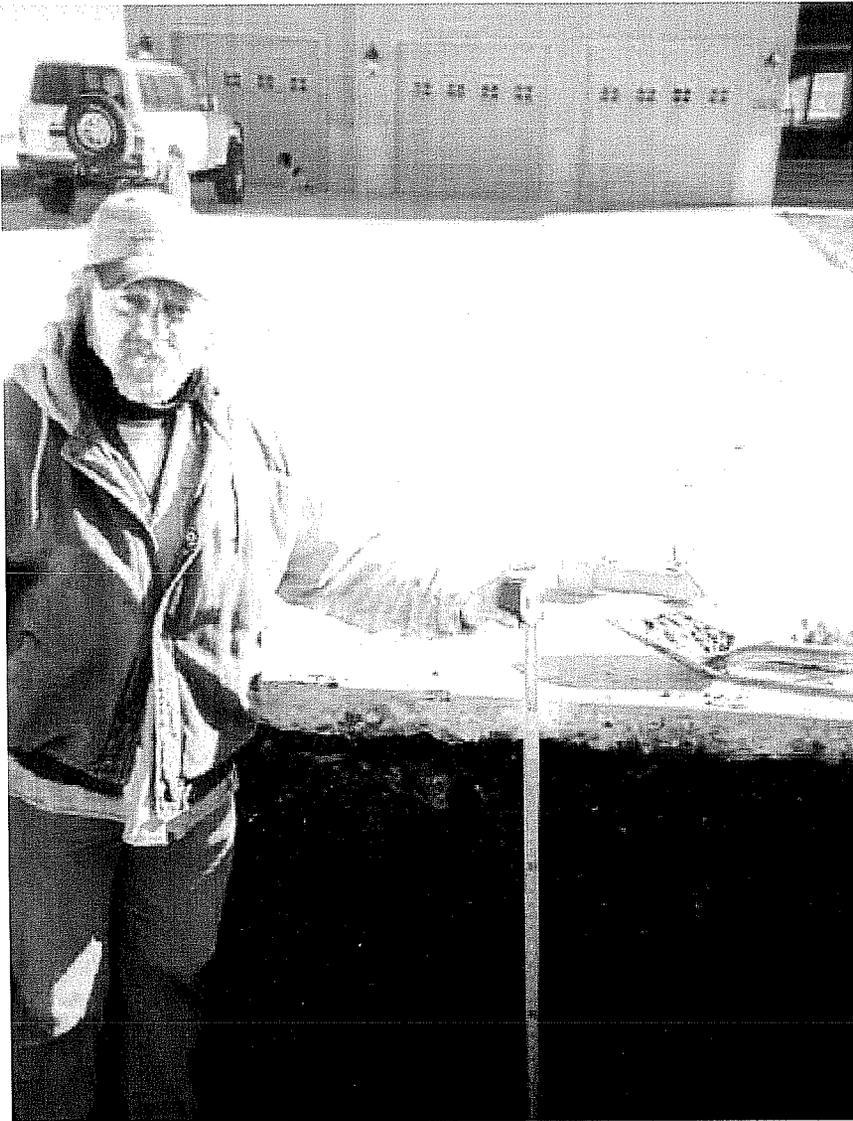
Perspective of depth on the damaged line.

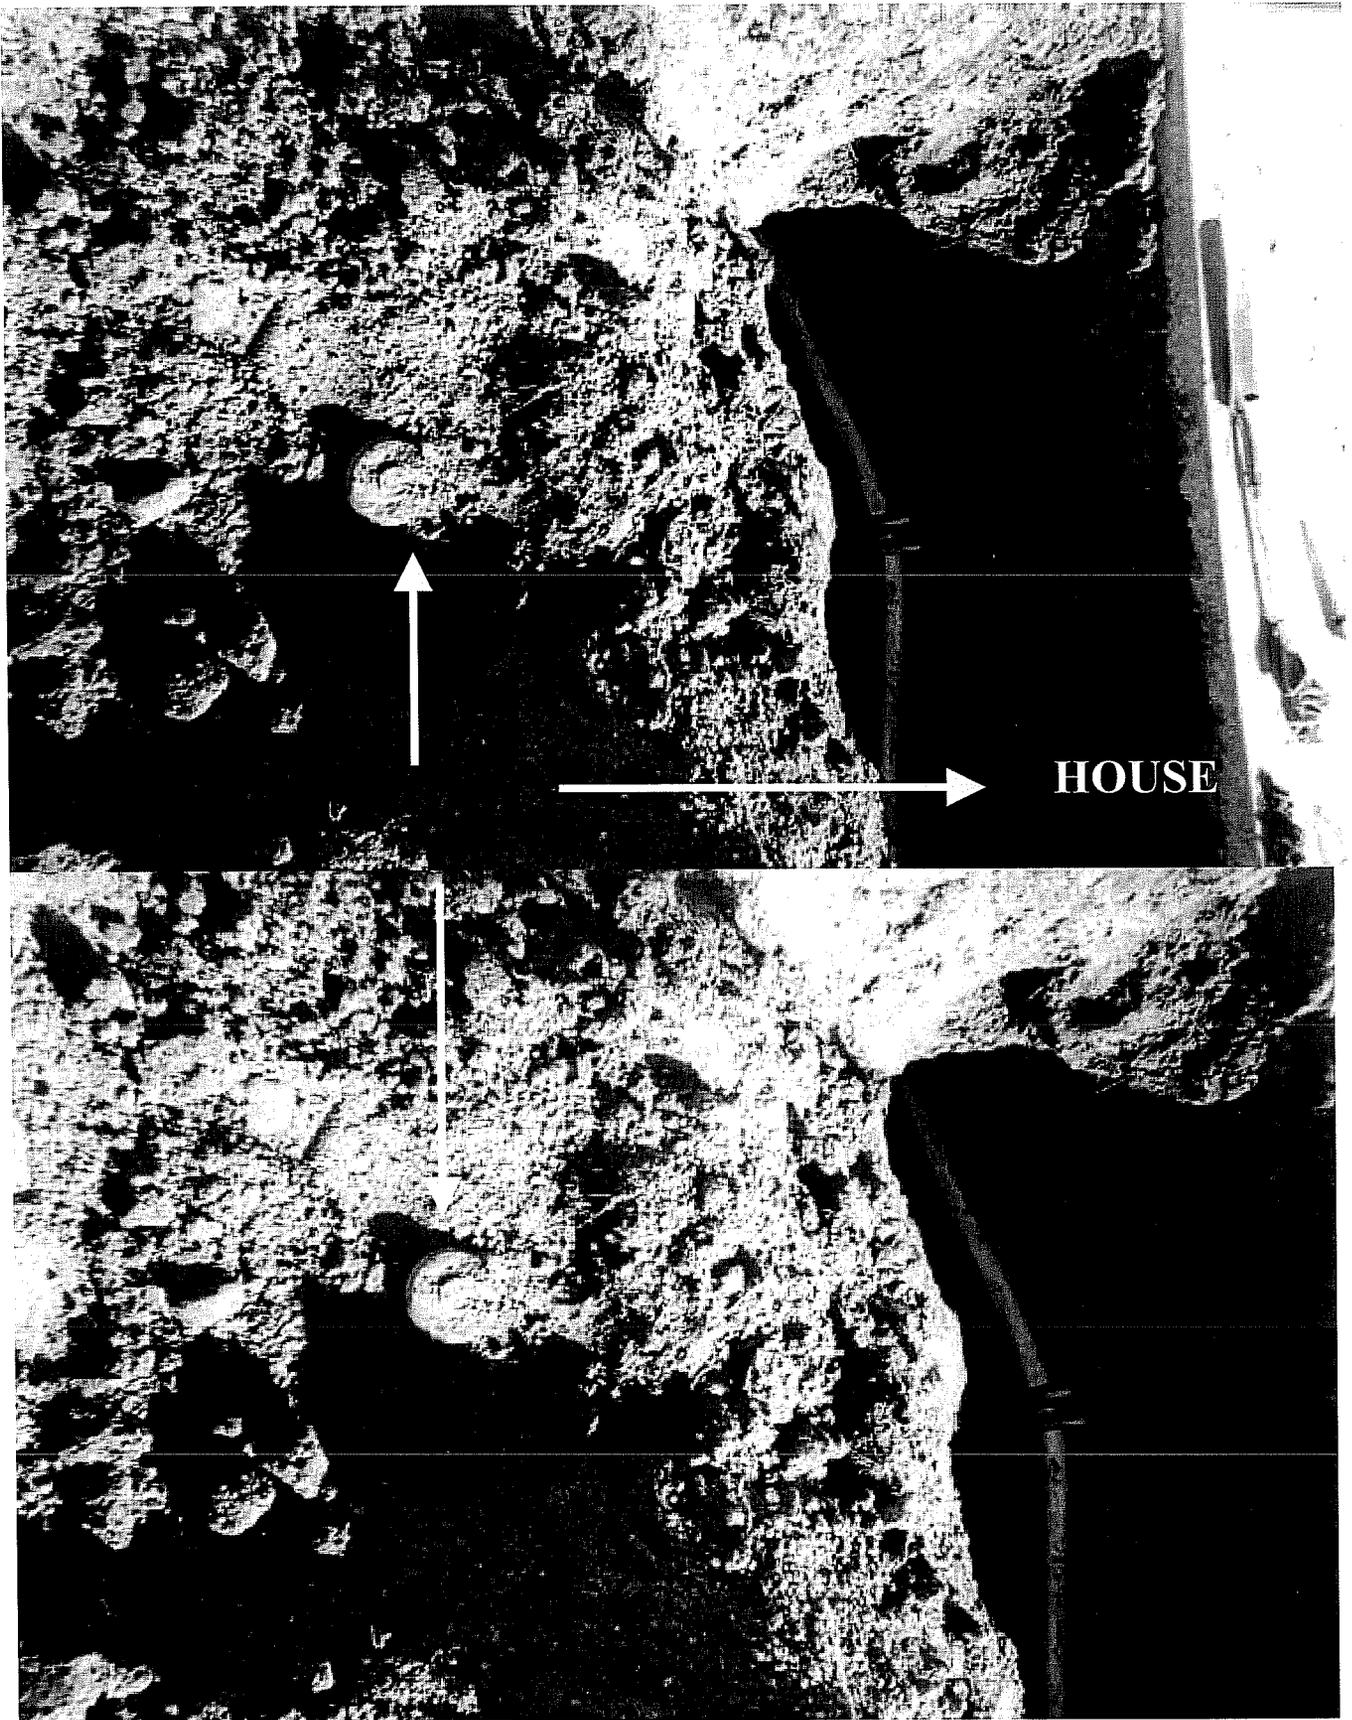
More views of the water curb valve in relation to the damage.
