**UTILITY DAMAGE REPORT**

Watertown Municipal Utilities - 901 4th Ave. S.W. - Watertown, SD 57201 - (605)882-6233

Address/Location of Damage: 38TH AVE & 454TH ST (AKA) 7TH ST.

Damage Report for 7th ST. NW concerning Belair Excavating.

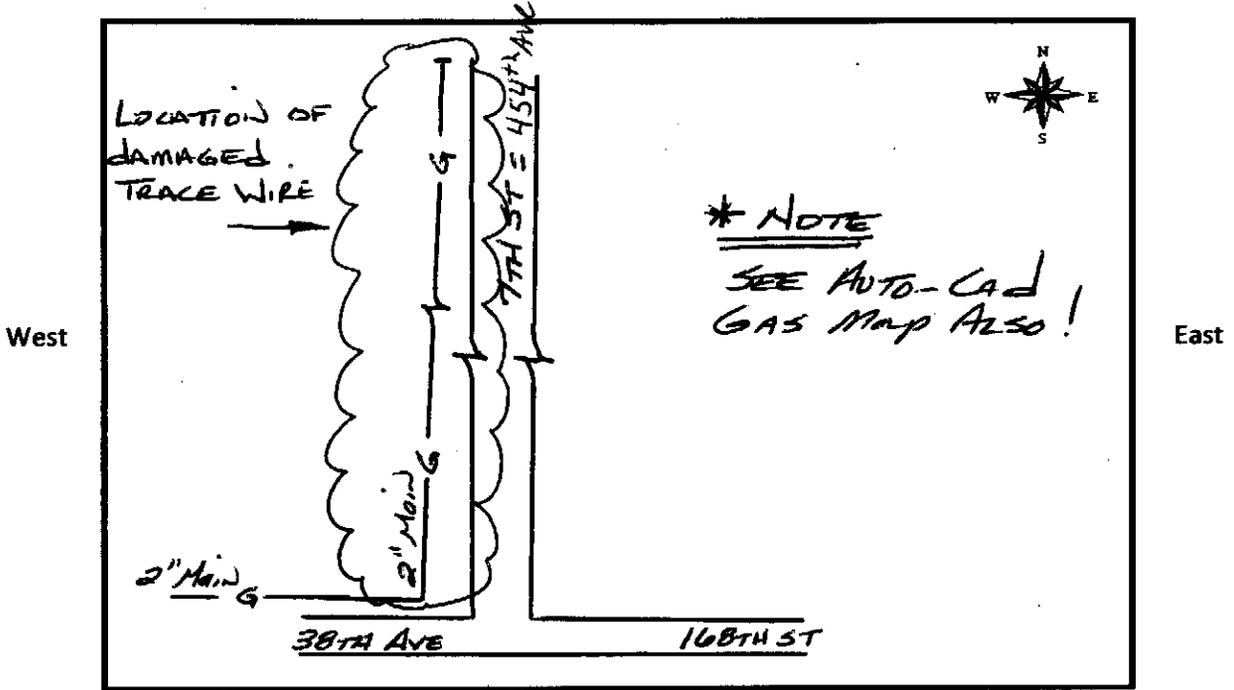
# Diagram the Utility Damage

- (1) Bryan Warberg discovered the damaged trace wire locations on Sept. 9<sup>th</sup>, 2010
- (2) ATTACHED ARE FOUR one-call LOCATE REQUESTS FOR THE GENERAL WORK AREA OF DAMAGED TRACE WIRE.

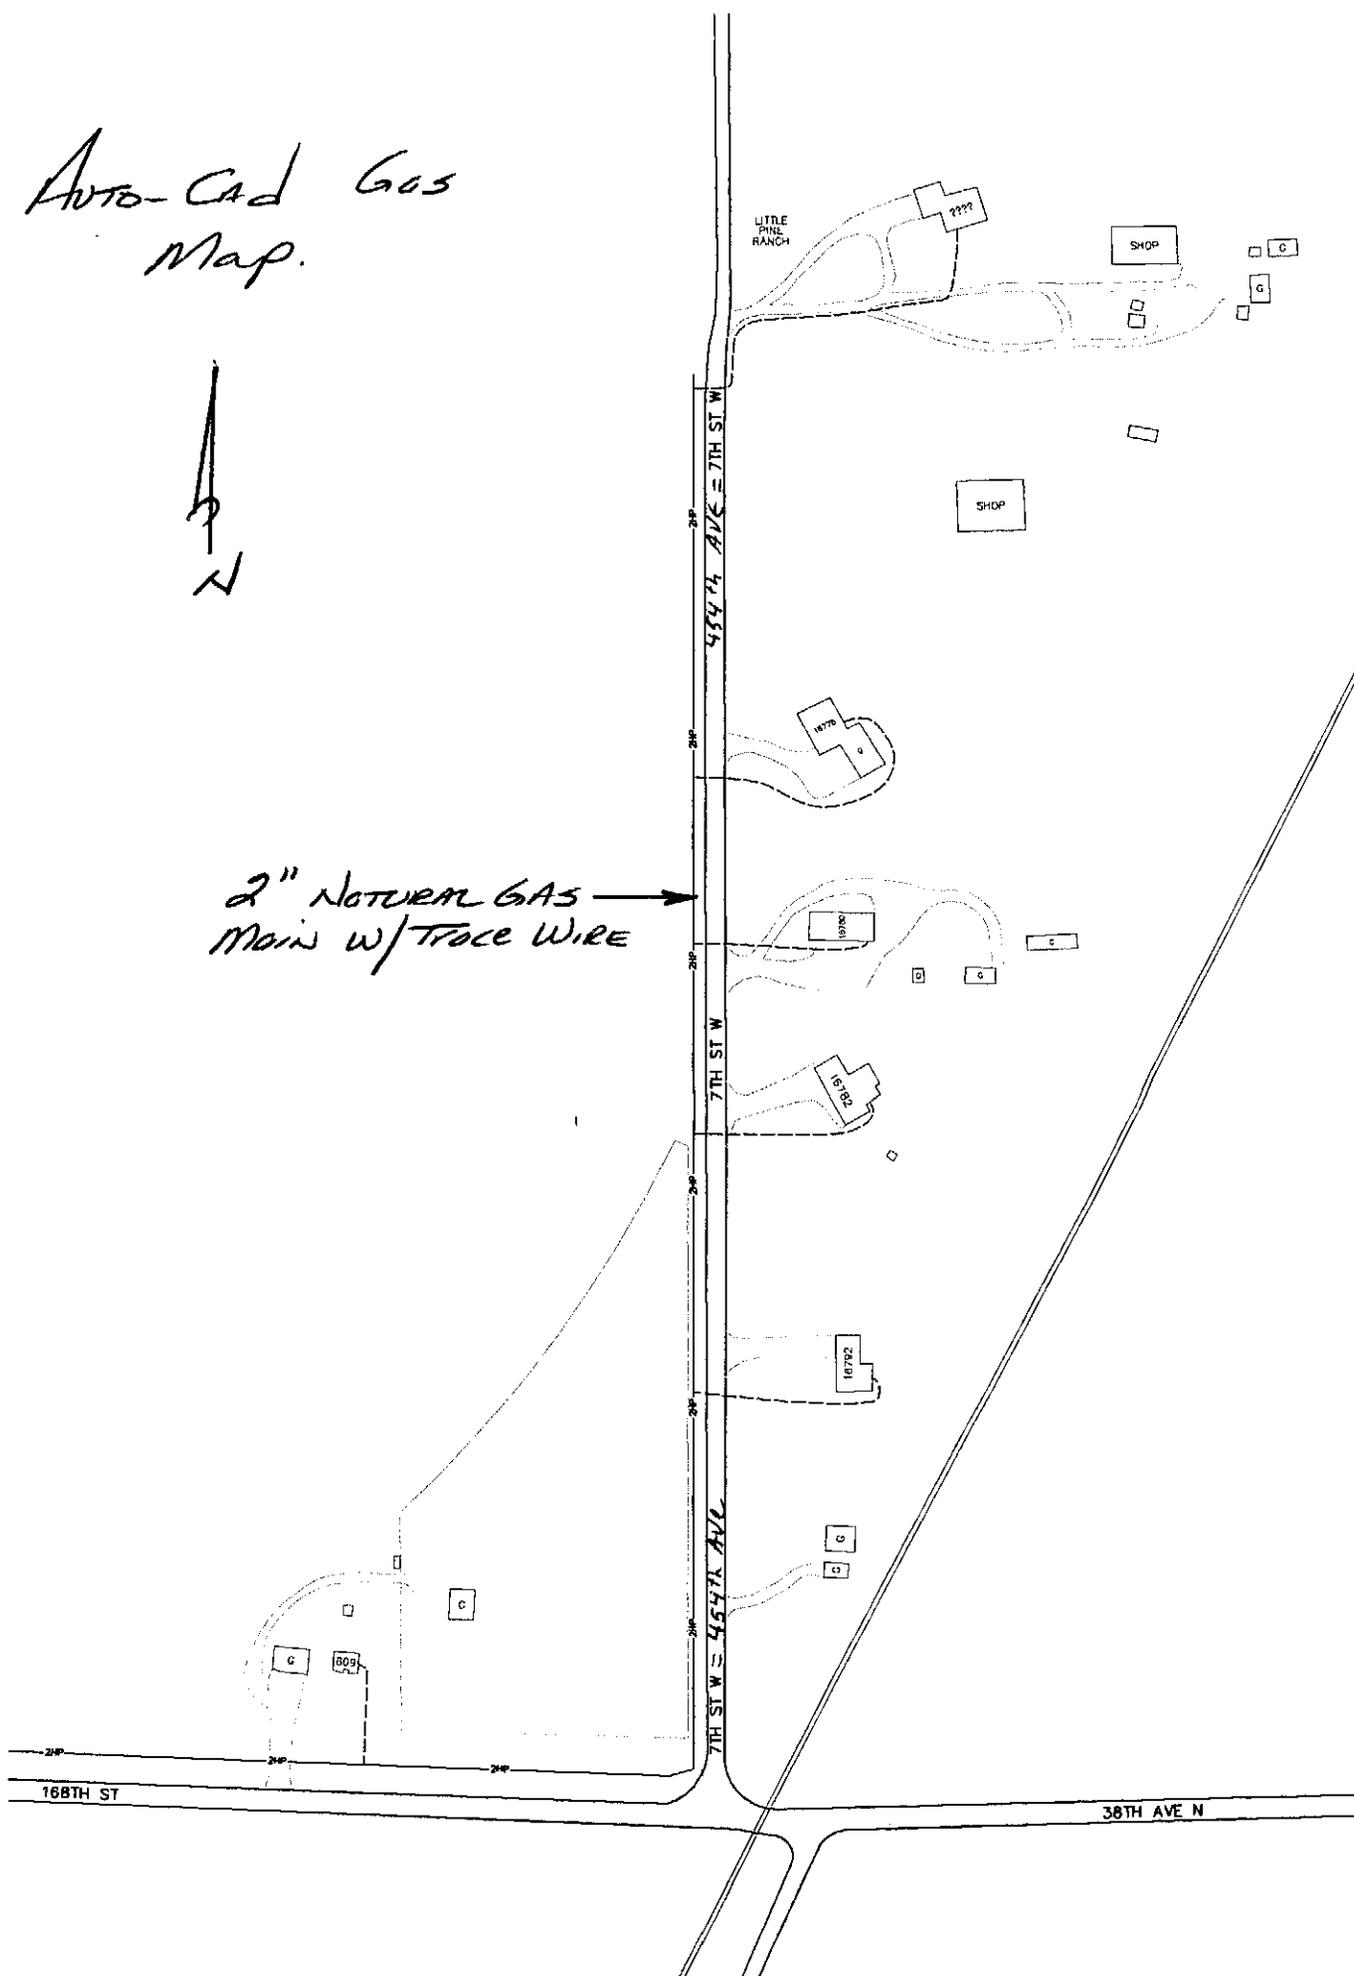
# Auto-CAD Gas Map.

I was called on September 9<sup>th</sup> 2010 by Belair Excavating Supervisor Terry Spitzer to locate our gas on 7<sup>th</sup> ST. NW as they were in the process of searching for a leak on a newly installed water main. I instructed him to call in a locate ticket and that I would try to get there as soon as I could. I responded to his request around 10:00am. When I hooked up to our gas system via gas service lines I discovered that the signal strength and conductivity of the line had been changed from when I had located it for Belair when they installed the pipe originally and that the tracer wire was not tracing the way it should. As I continued following the signal to the main, I noticed that it no longer pulled to the anode, which usually indicates a cut tracer wire in the system. I followed the signal along the main and noticed that the depths of the line changed significantly (from 3 to 8 feet) and finally lost it all together. I hooked up to the rest of the services along 7<sup>th</sup> ST NW where Belair had been working and discovered the same throughout the entire area (approx 1600'). I asked Jerry Burns (WMU gas Foreman) and Aaron Vollmer (AE2S Engineering) to accompany me out there after lunch. We dug up one of the areas that I suspected the wire had been cut and we confirmed that it had. The wire was only 10" deep in this area, and when we fully excavated wire, we discovered that it was wrapped around a piece of lath, coiled up and buried (pictures were taken). There are other areas along this 1600' that are the same way, the tracer wire has been either cut or is no longer with the pipe throughout Belair's excavation area.

2" NATURAL GAS MAIN W/TRACE WIRE
