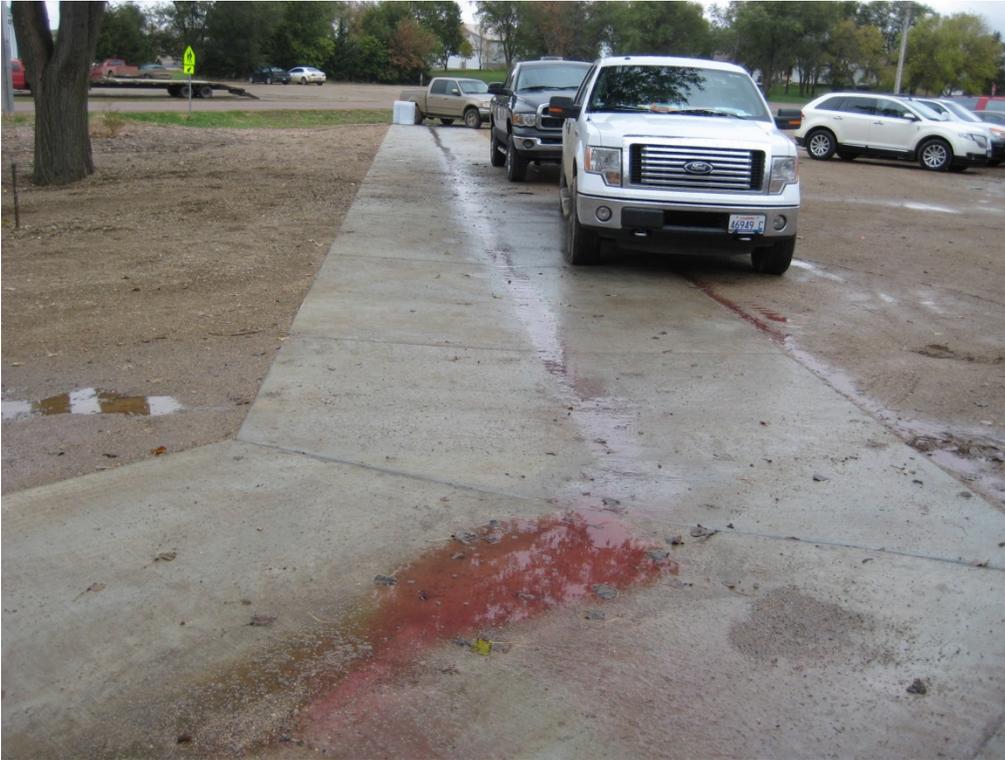
Photo #1: Site conditions upon arrival 10-23-13; valley gutter looking southeast

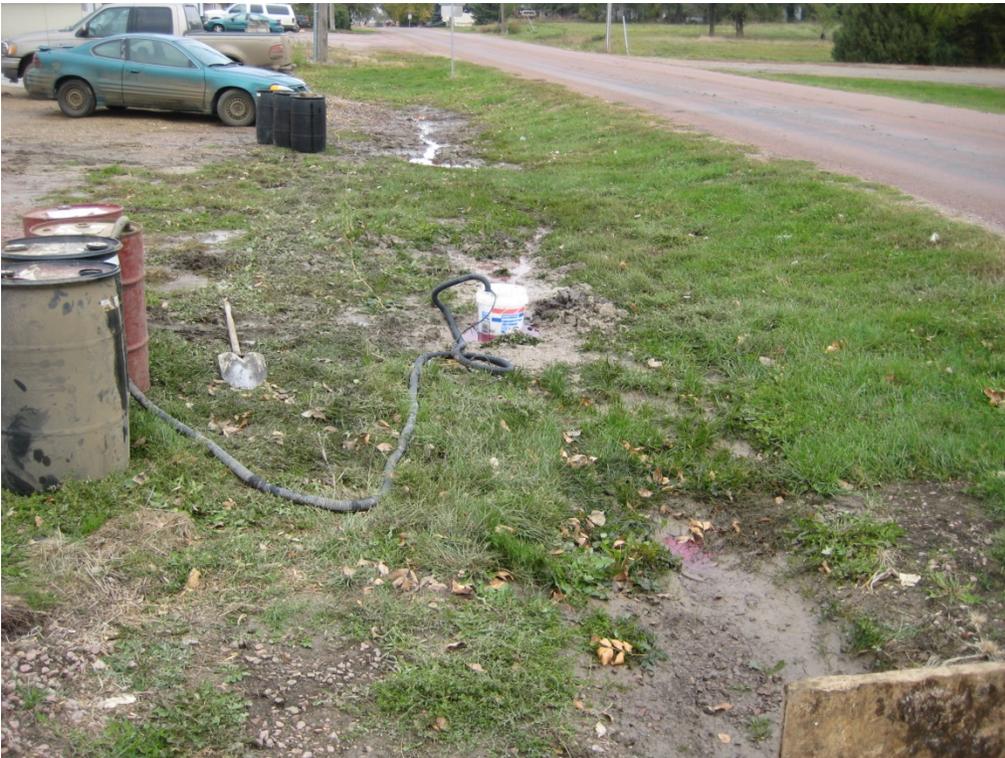
Photo #2: Site conditions upon arrival 10-23-13; west ditch of Truck Street

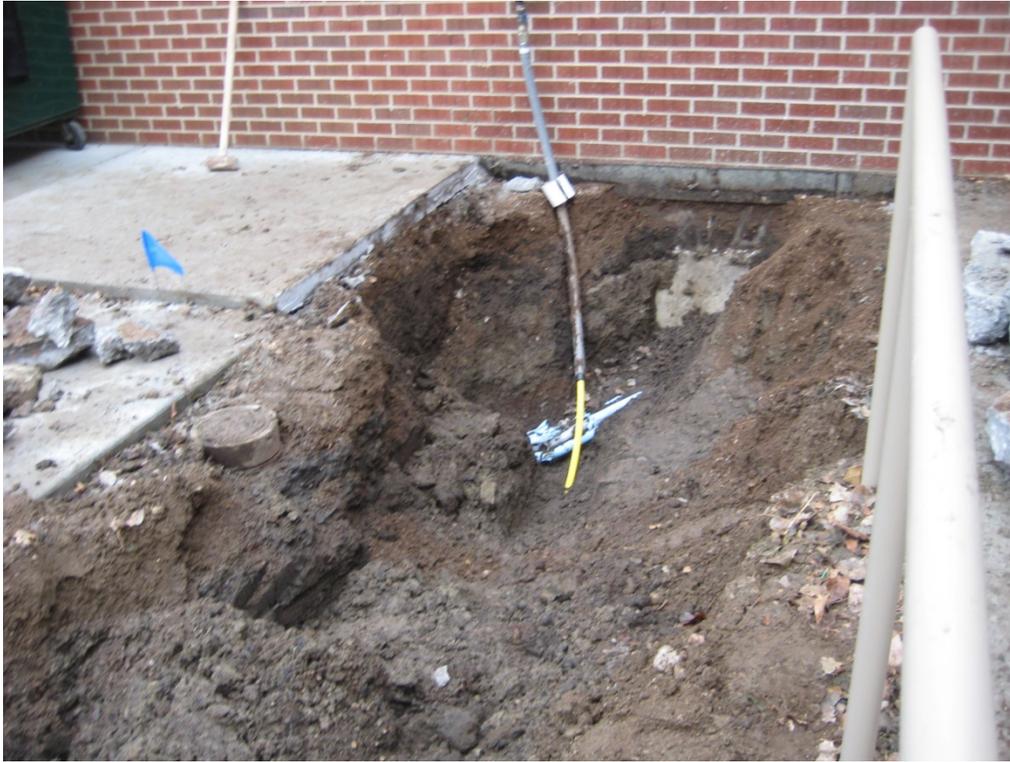
Photo #3: Exposed propane line and product line; 10-23-13; looking north

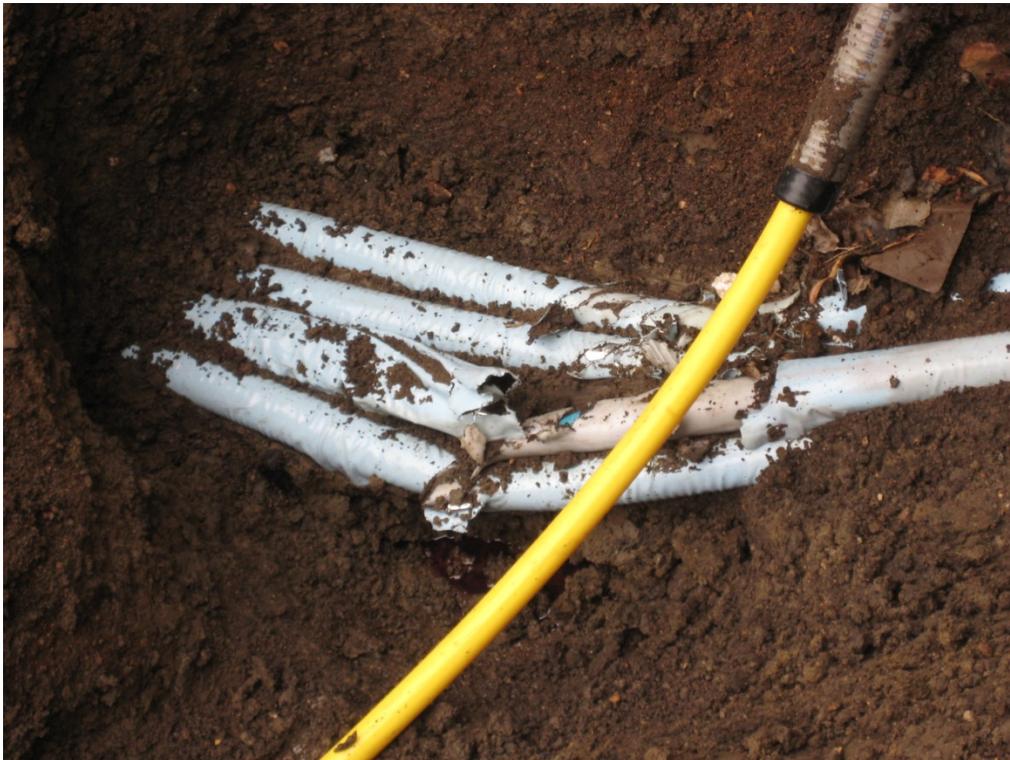
Photo #4: Exposed propane line and product line; 10-23-13

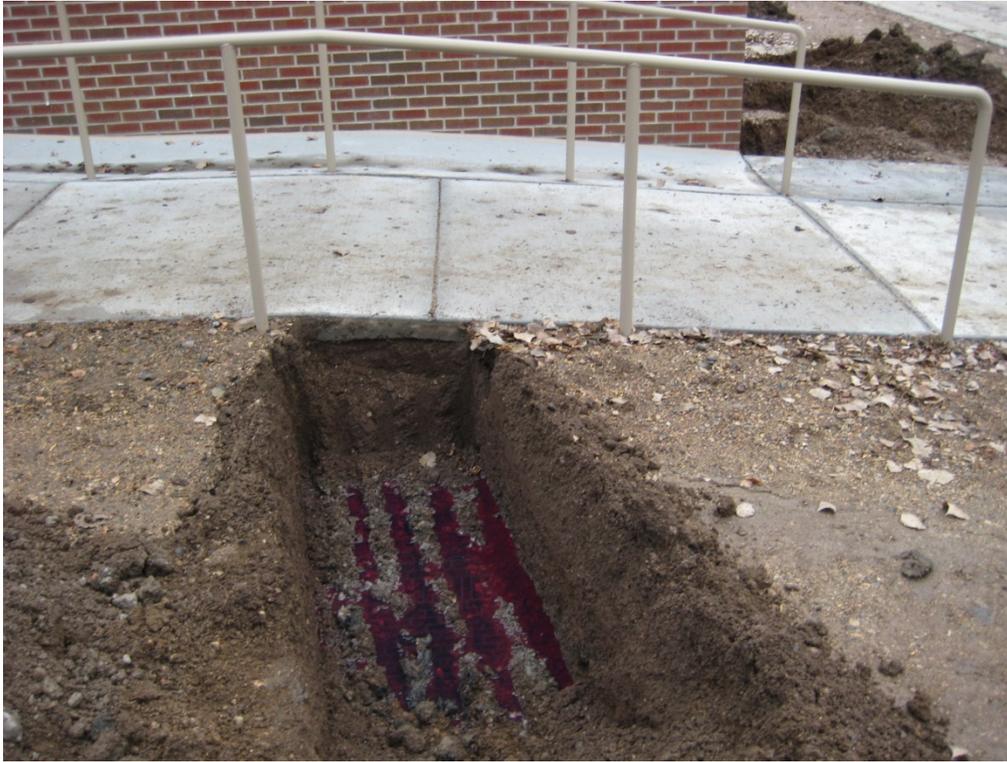
Photo #5: Test pit south of sidewalk; 10-23-13; looking north

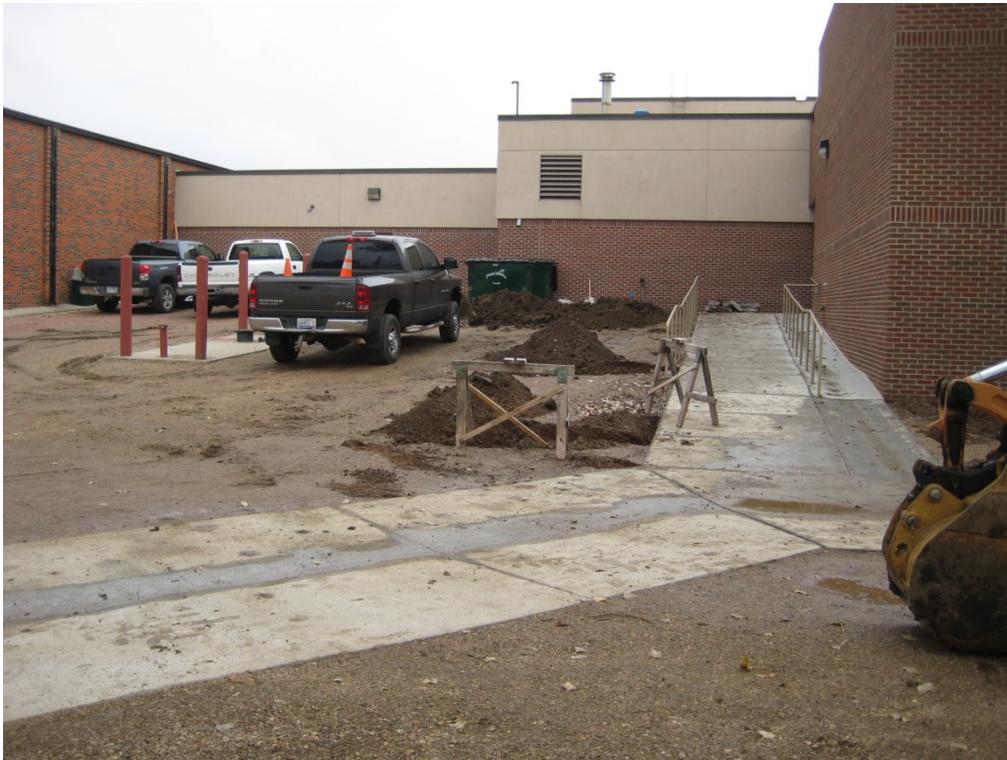
Photo #6: Test pit locations, south of sidewalk; 10-23-13; looking west

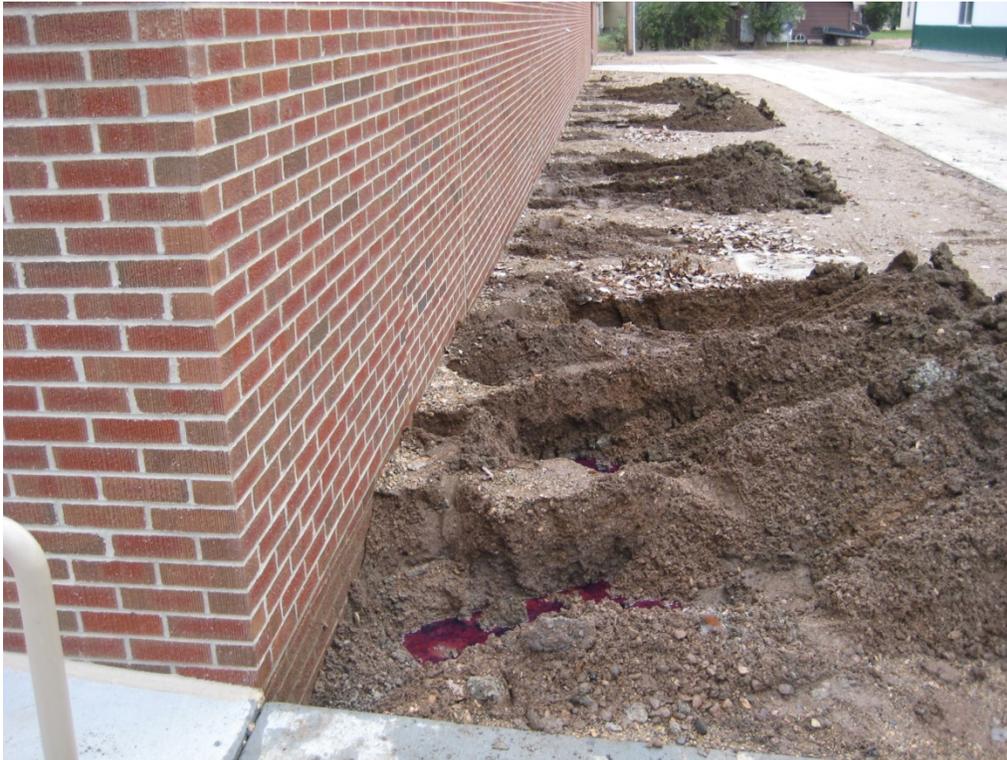
Photo #7: Pits excavated along east side of building; 10-23-13; looking north

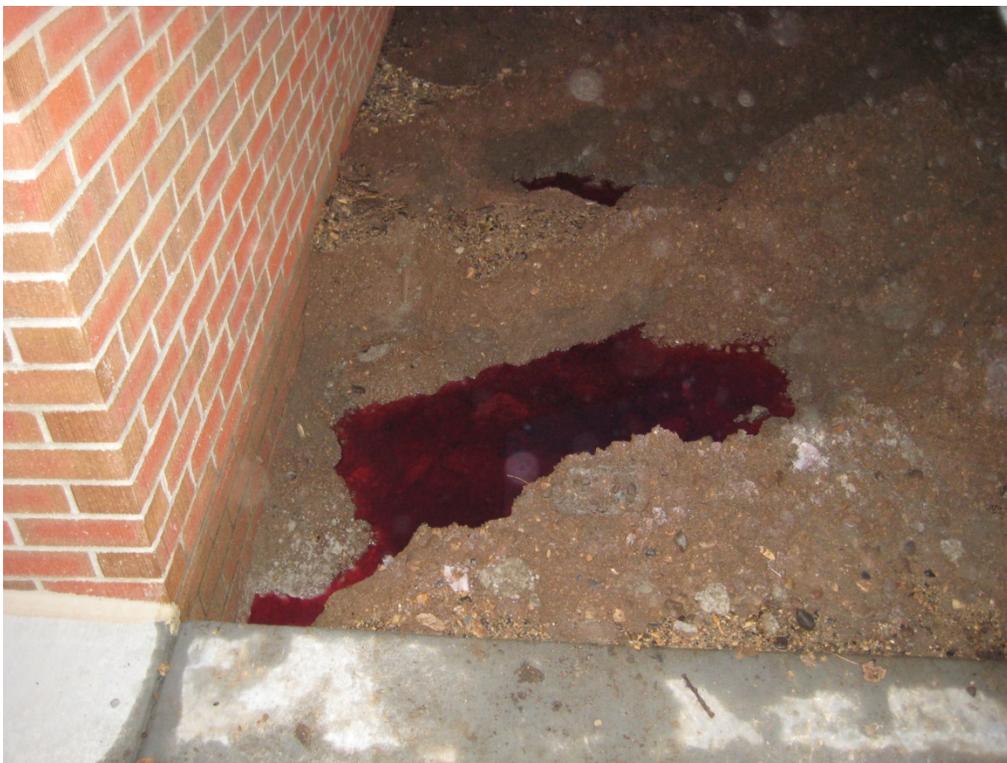
Photo #8: Accumulated product in pit overnight; 10-24-13; looking north
