COMPLAINT

ALLEGATION OF PROBABLE VIOLATION(S) OF SOUTH DAKOTA ONE CALL LAWS

TYPE OF FACILITY INVOLVED: 2" polyethelyne natural gas main OPERATOR OF FACILITY (IF KNOWN): Montana-Dakota Utilities Co.

ADDRESS/LOCATION OF PROBABLE VIOLATION: 16630 Elk Horn Rd, Piedmont, SD

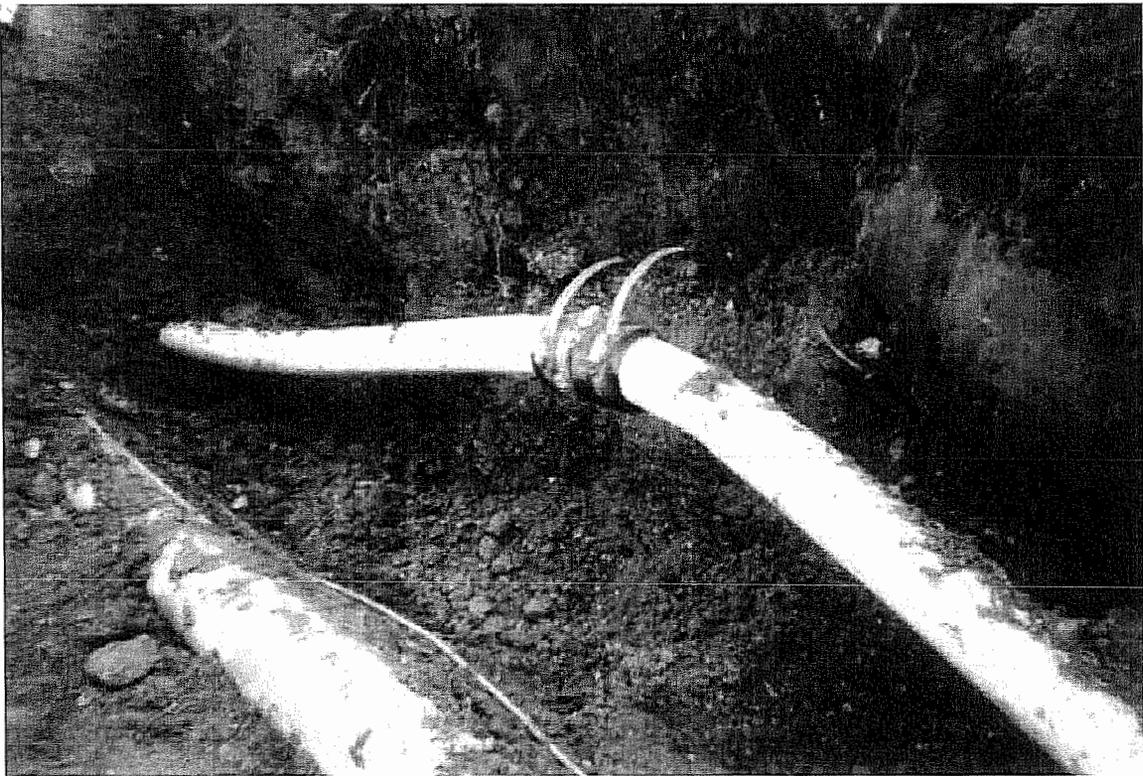
Notice the extreme upward bend in the pipe. This damage was obviously caused by a Backhoe or some other power equipment.

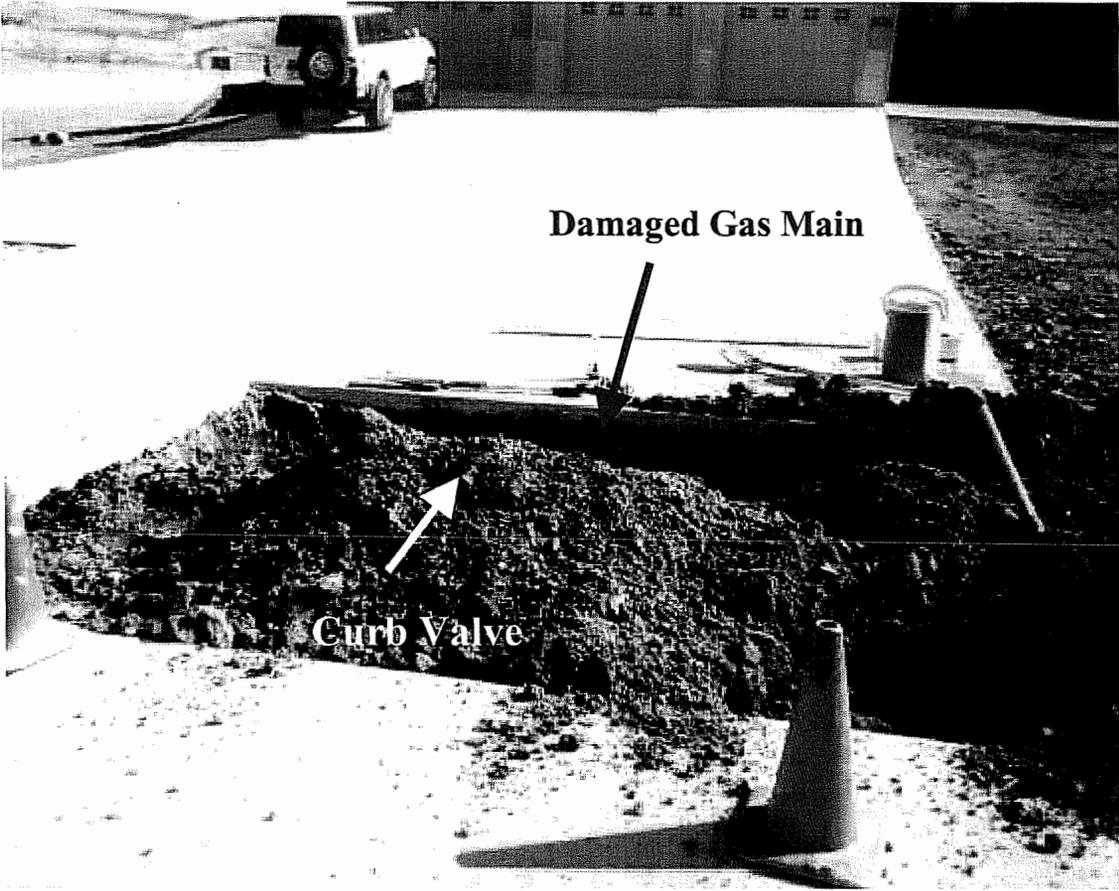
More views of the water curb valve in relation to the damage.
