## INCIDENT INVESTIGATION #209087

Oneida and Pleasant, Pierre, SD

**Line Size and Type:** 2.00" Plastic

**Root Cause:** Excavator dug prior to verifying marks by test-hole (pot-hole)

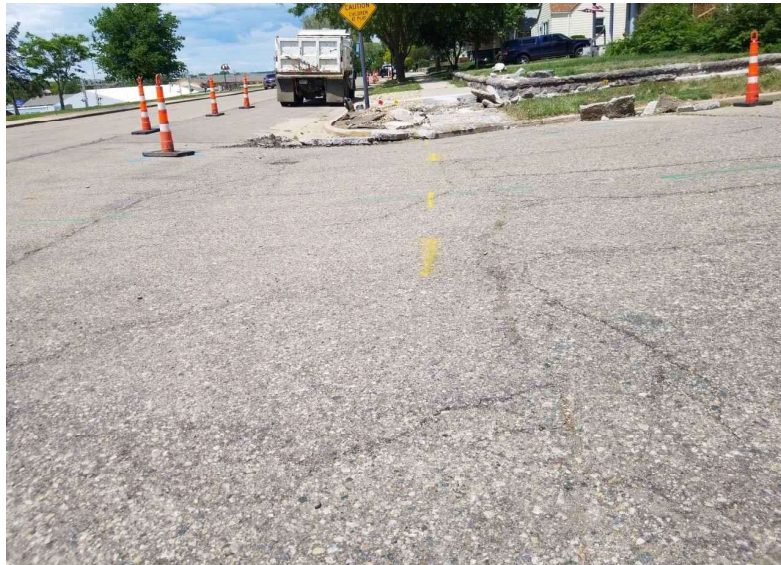
## SURVEY PHOTO

Ticket: 2114816873.0 Timestamp:6/1/2021 1:13:52 PM

**Assessment Comments:** 2" gas main was damaged by Anderson Contracting . Gas main was marked accurately no deviation at all. Contractor did not look for gas before digging and hit the gas main with his bobcat. Gas was blowing and fire department and police officers were on site. 811 was notified. Contractor was also digging before the legal start time.

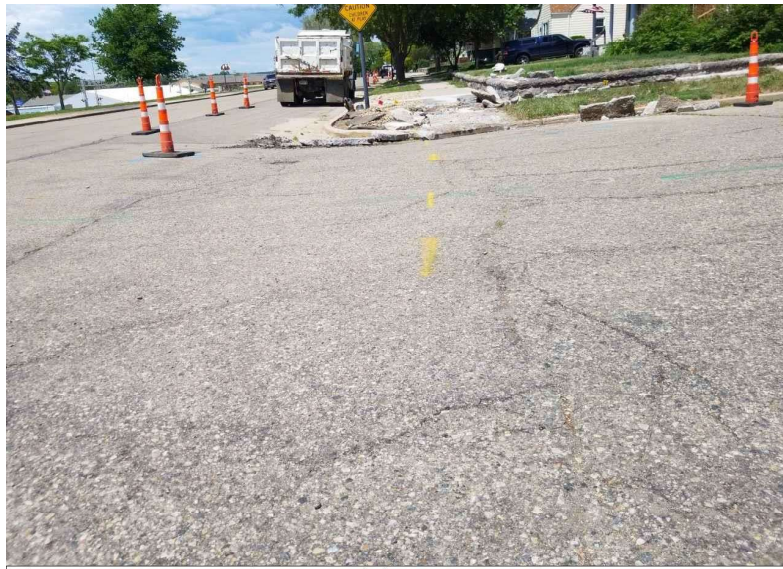
## SURVEY PHOTO

Ticket: 2114816873.0 Timestamp:6/1/2021 1:13:52 PM
