UTILITY DAMAGE REPORT

Watertown Municipal Utilities - 901 4th Ave. S.W. - Watertown, SD 57201 - (605)882-6233

Address/Location of Damage: 20th Ave SE.

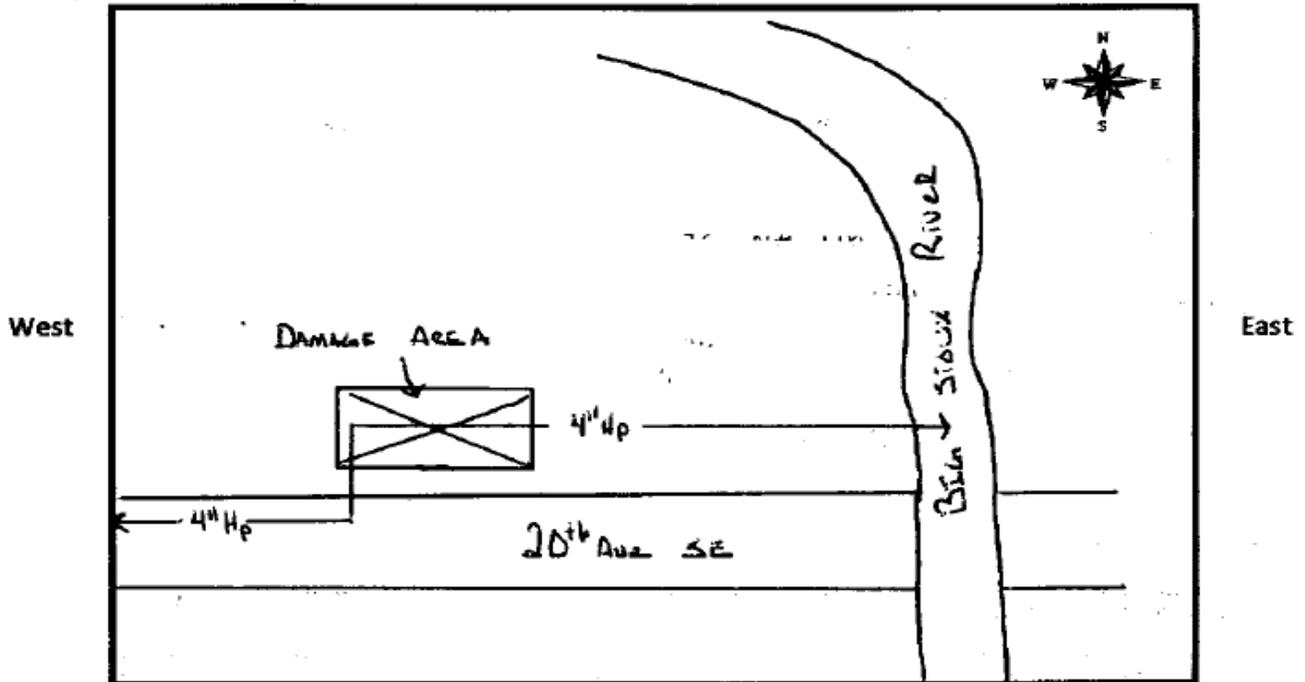
Diagram the Utility Damage

Damage was to 4" Hp & Tracer wire. The 4" Hp main was scraped but not cut & the tracer wire was cut & stretched. Derrick with Bowis Const. informed us of the damage. Grandgard Construction was the damaging party and was not present on our arrival. No locate had ever been requested by Grandgard on this project
