INCIDENT INVESTIGATION #205087

7916 Duke Parkway, Spearfish, SD

ROOT CAUSE

Root Cause: Marks faded, lost or not maintained

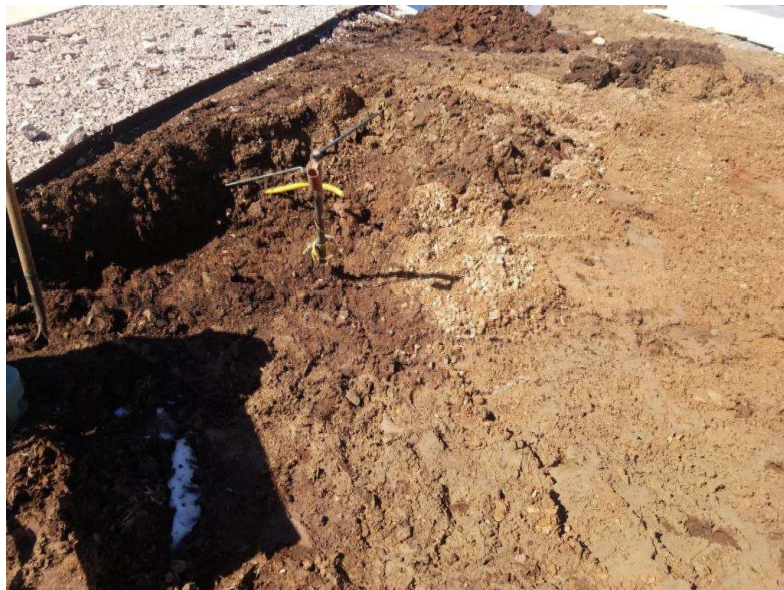
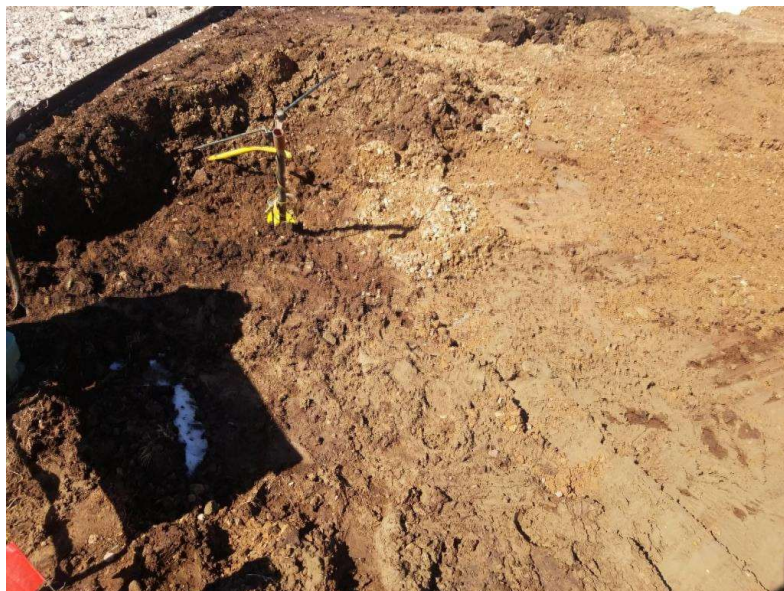
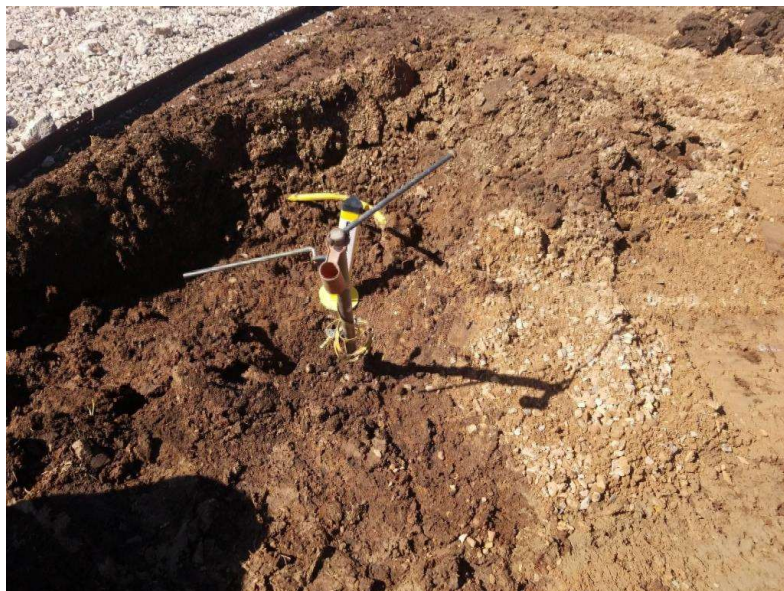
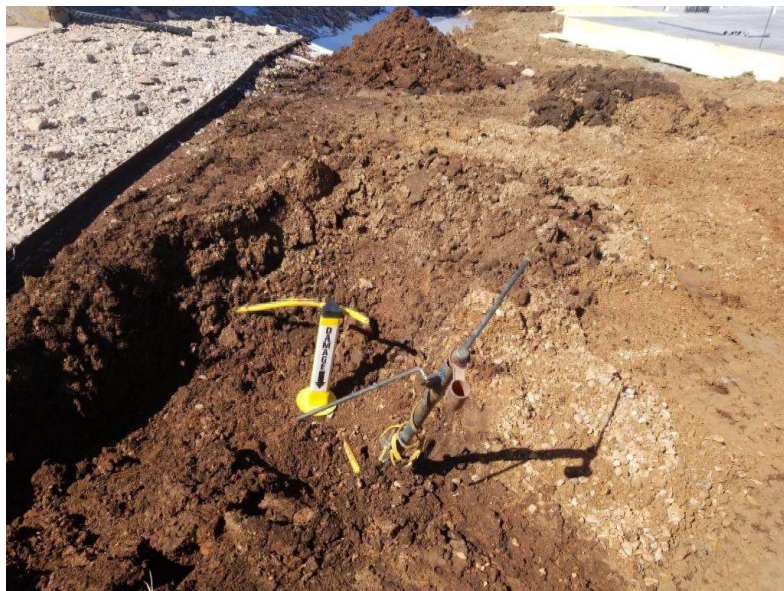
INCIDENT COMPARISON PHOTO

Assessment Comments: Located this ticket 2-24-21. Contractor dug on this ticket after snow melted, and then it snowed again. Damage took place between 9:30 and 10 am on 3-18-21. MDU did not get notified until 12:00. ELM did not get notified until 1:00 pm. Gas service at 7916 was hit digging trench for lot 12. With a Mini excavator. 911, 811 and MDU were all notified. Dale with MDU arrived to pinch off and fix line.
