INCIDENT INVESTIGATION #209202

500 pleasant , Pierre , SD

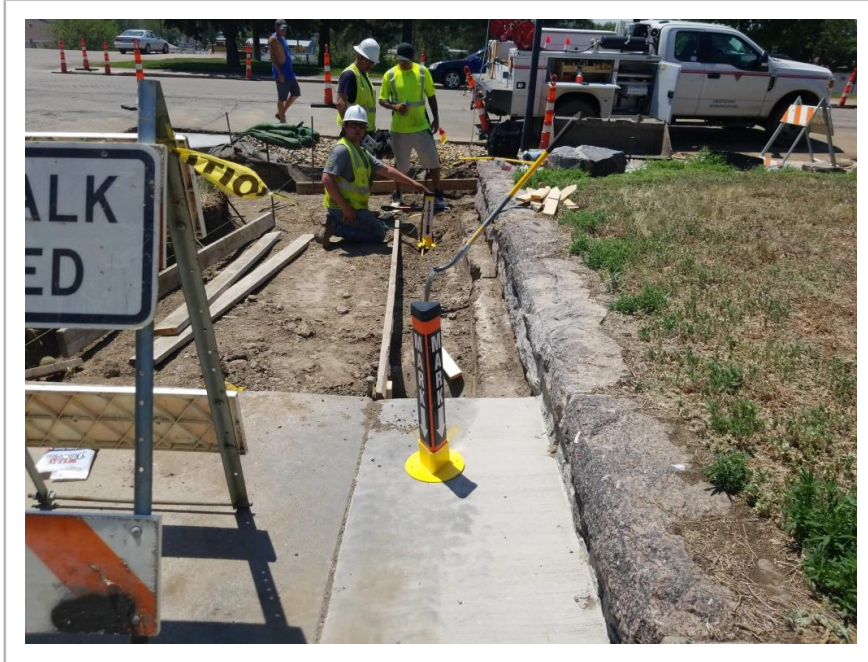
Assessment Comments: On June 8th the Montana Dakota utilities half inch plastic gas service to 500 pleasant street was hit by wooden stake. The service line was potholed and expose in 2 different areas in the work area and was still hit by pounding in a wooden post. marks were destroyed due to concrete being removed but from what marks were left the marks were right on. MDU said the contractor was definitely at fault gas was blowing and fire department was on site. 811 was notified.
